SESSION 3

Inspection and Maintenance of Dams and Spillways

Inspection of a dam

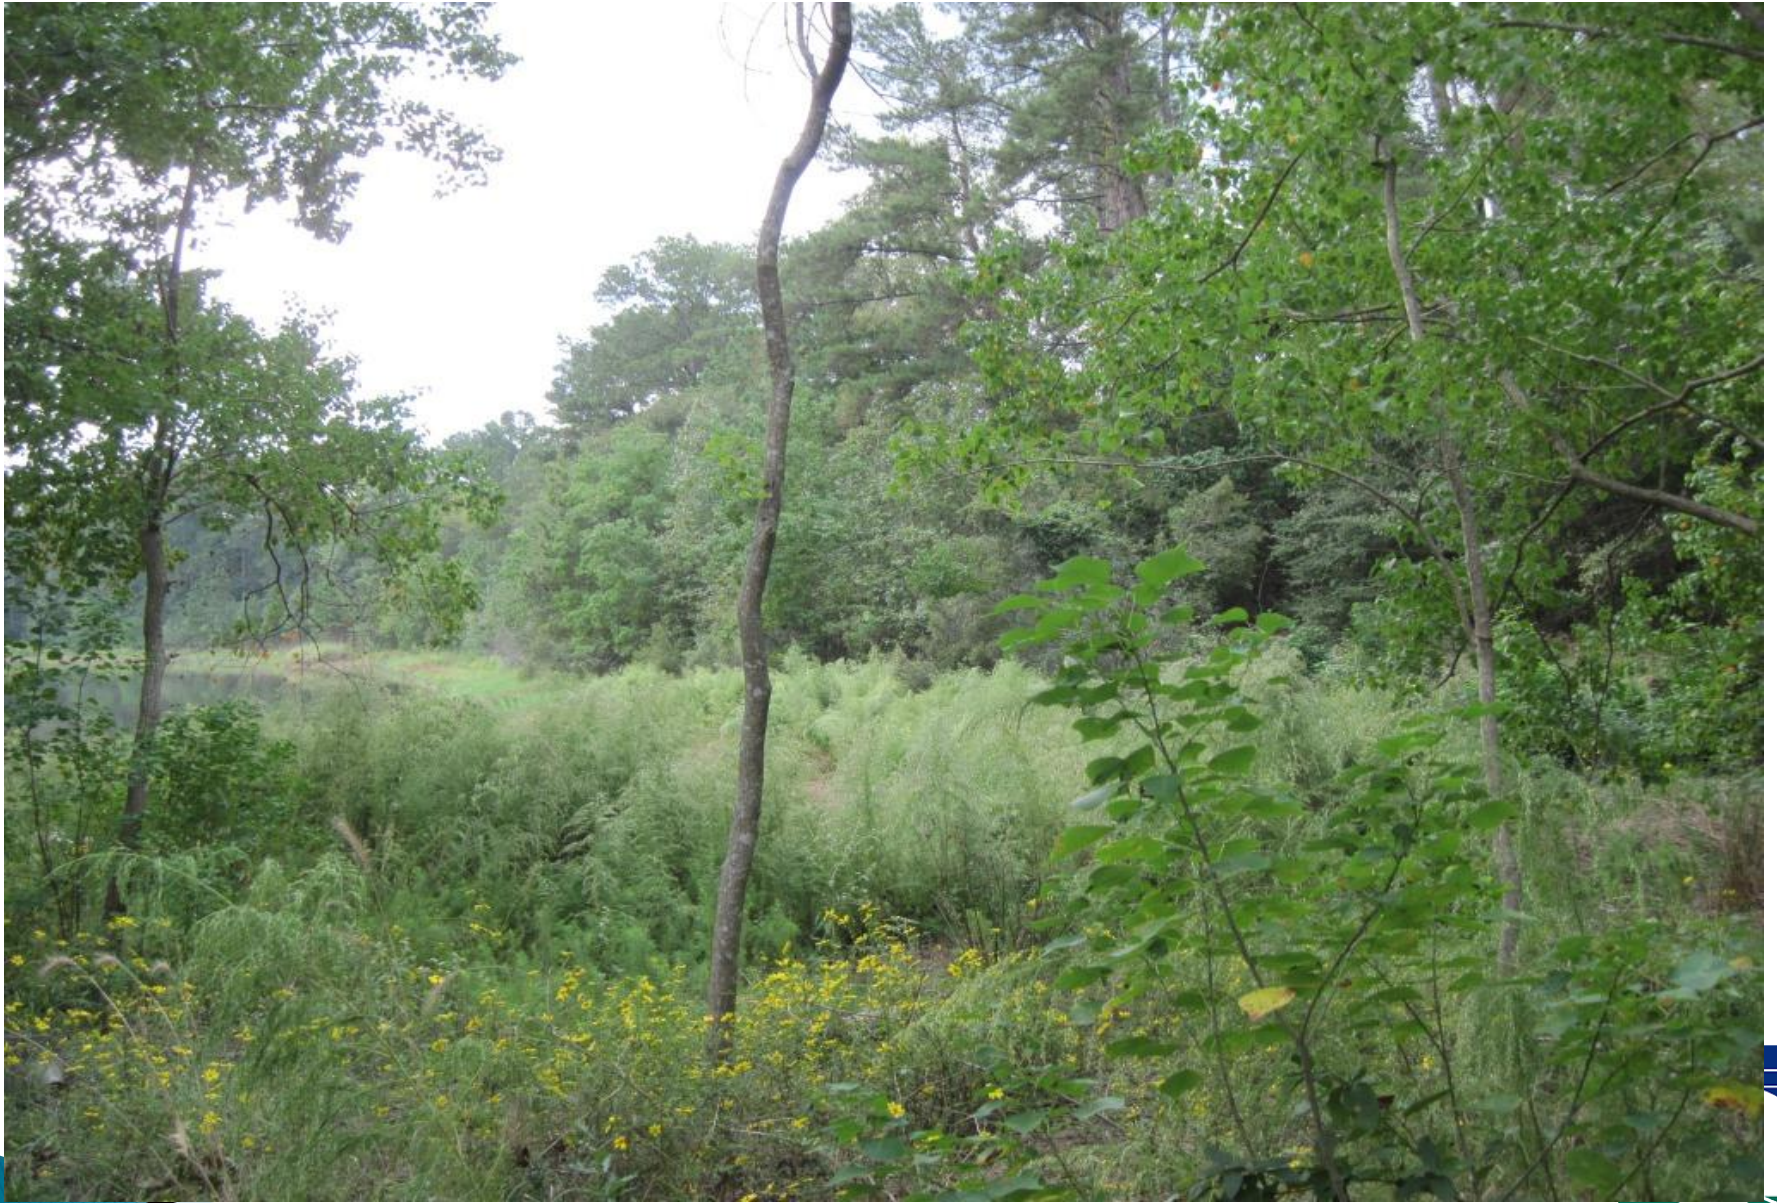
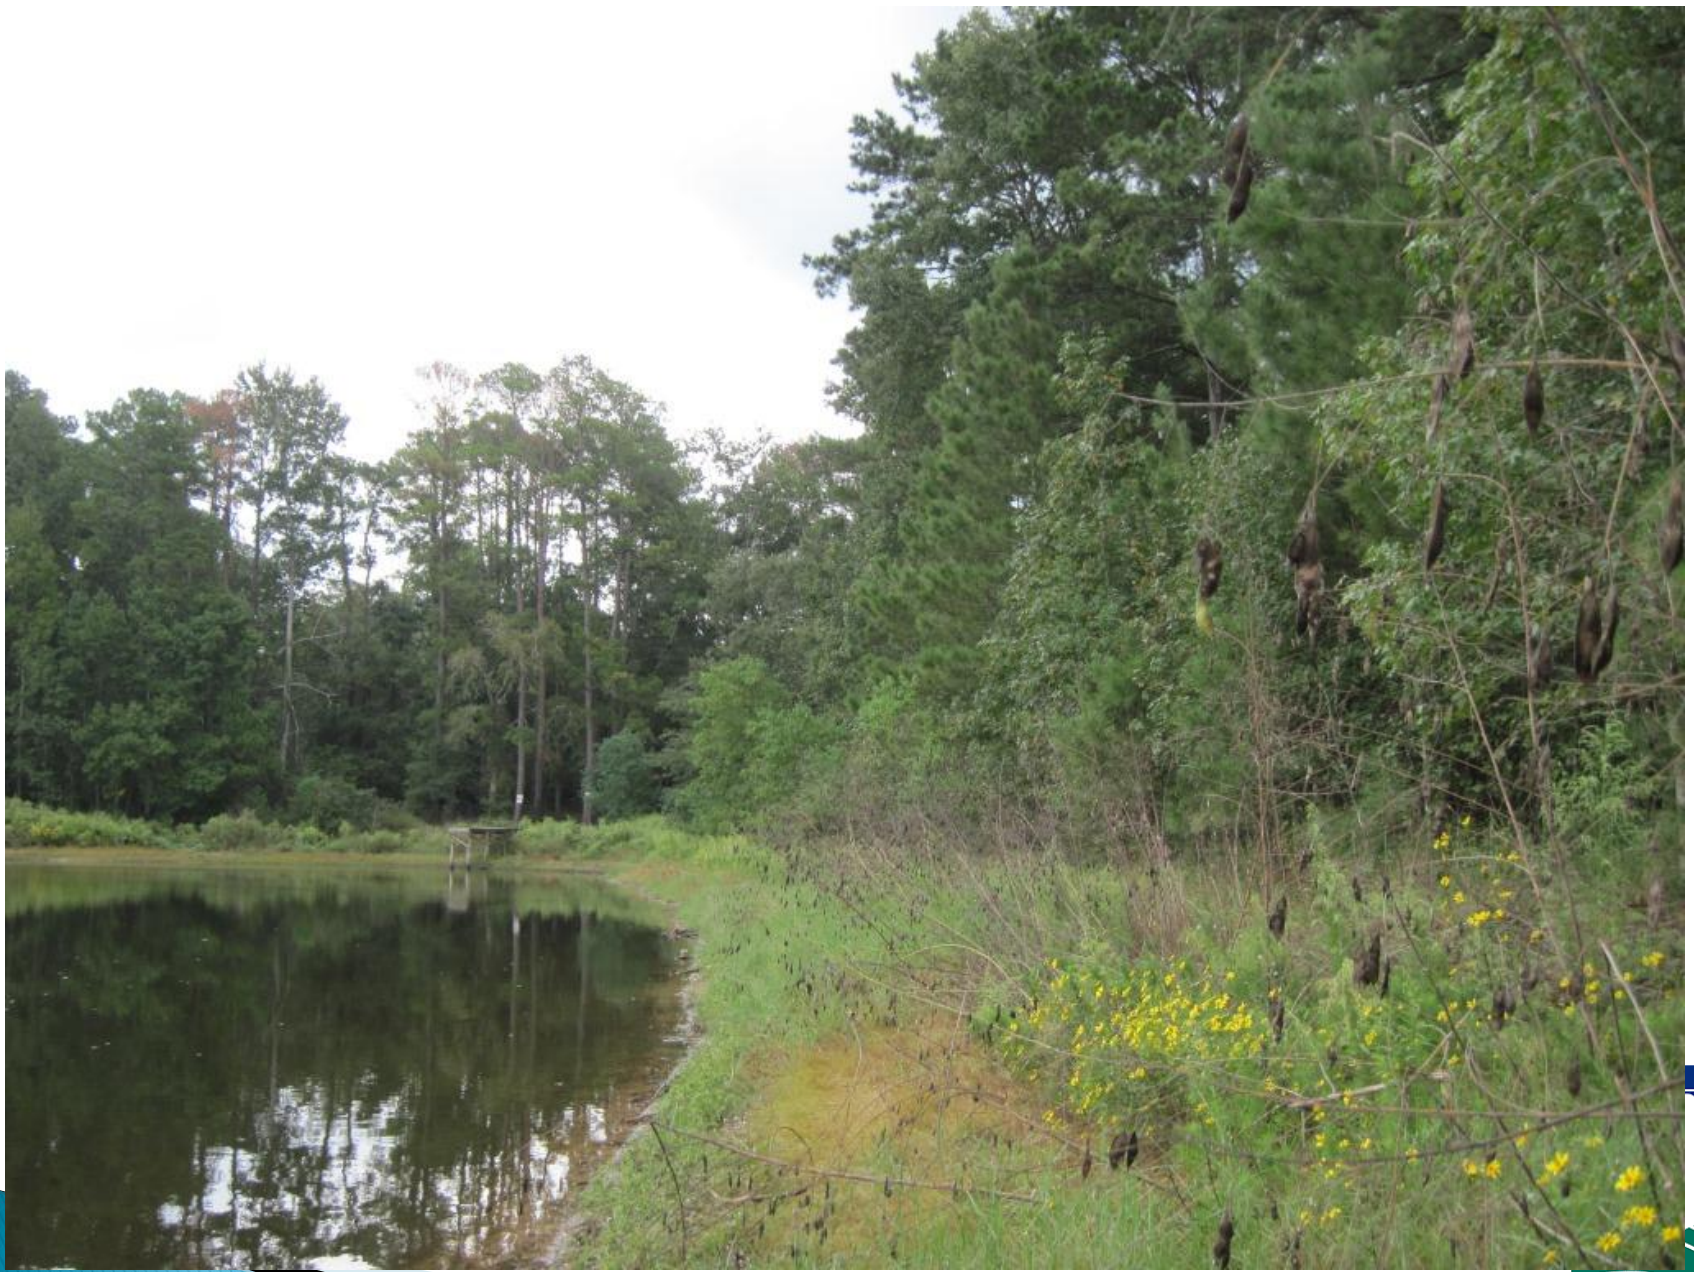
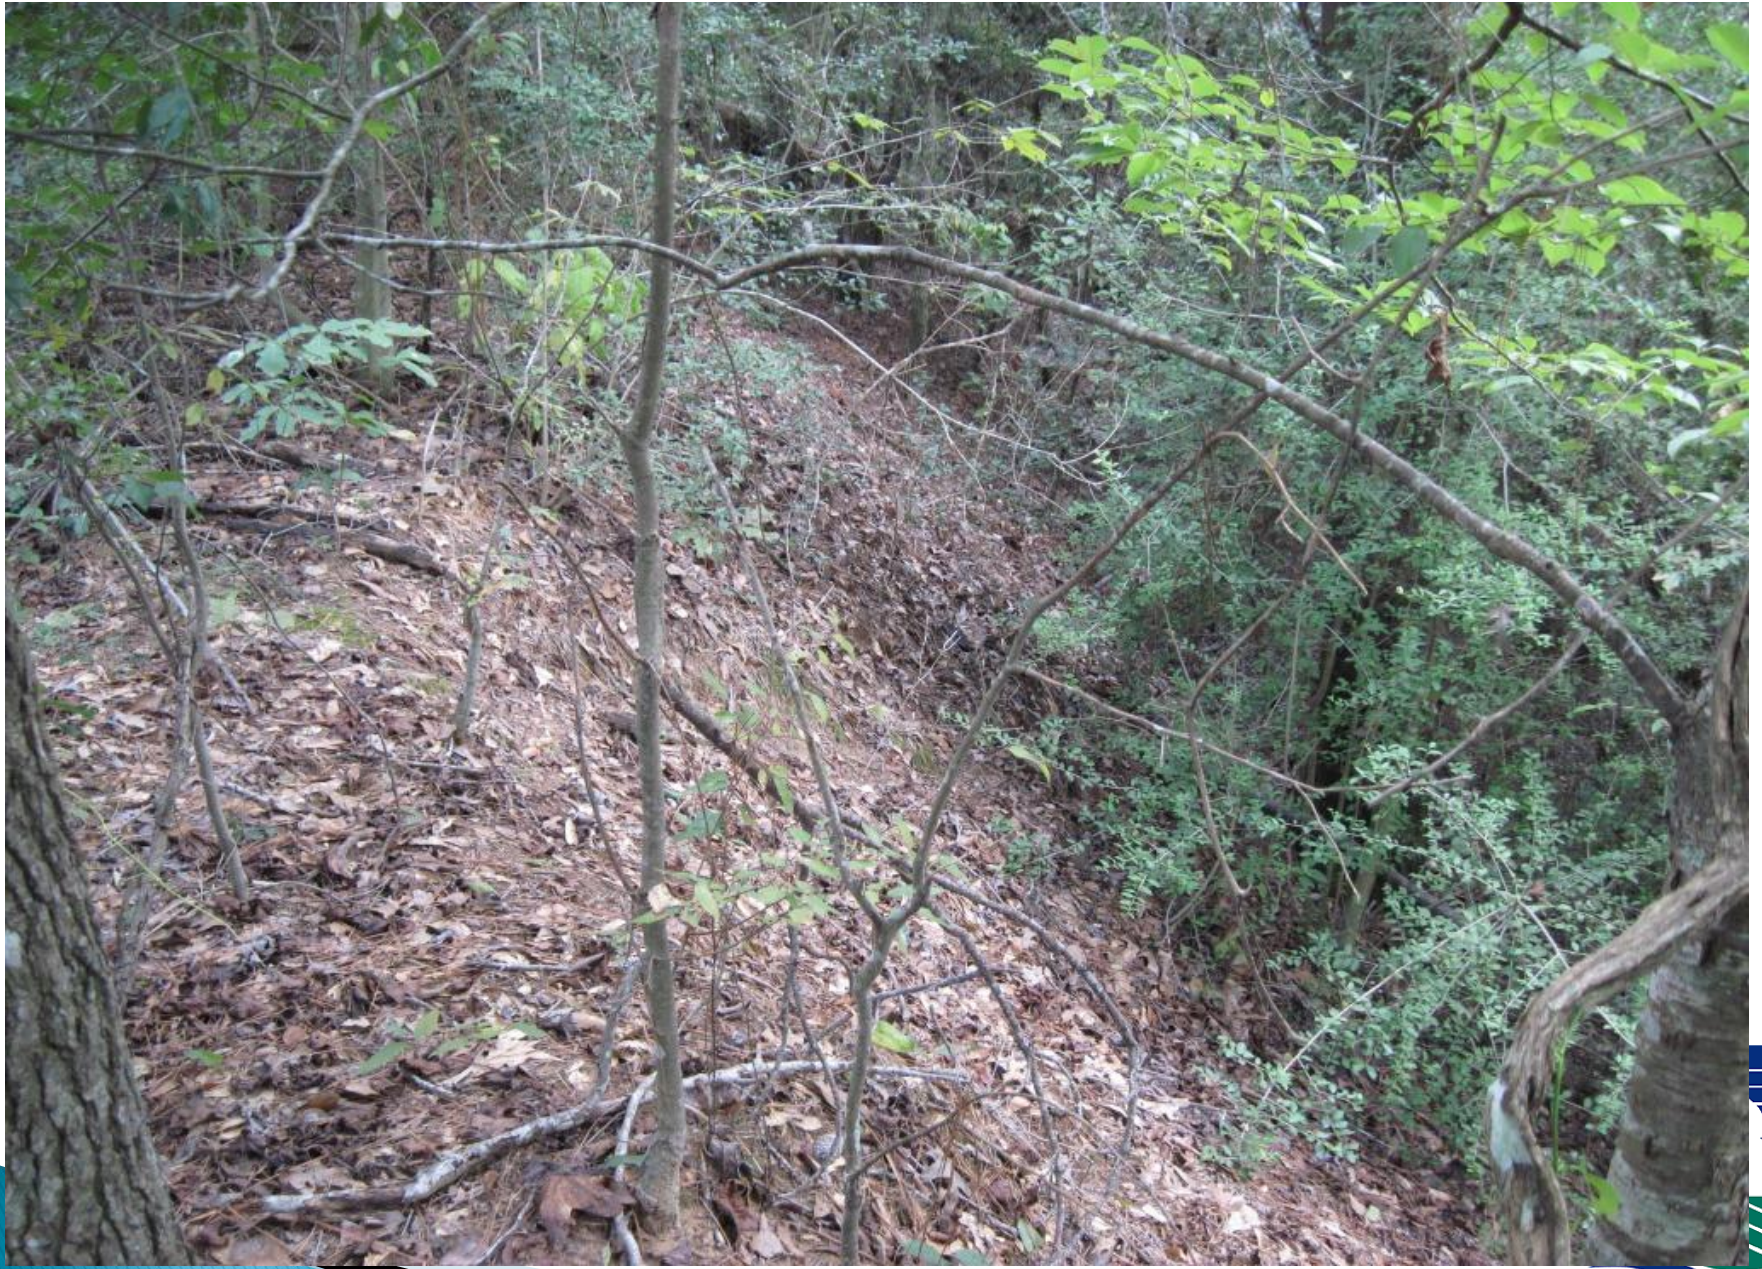
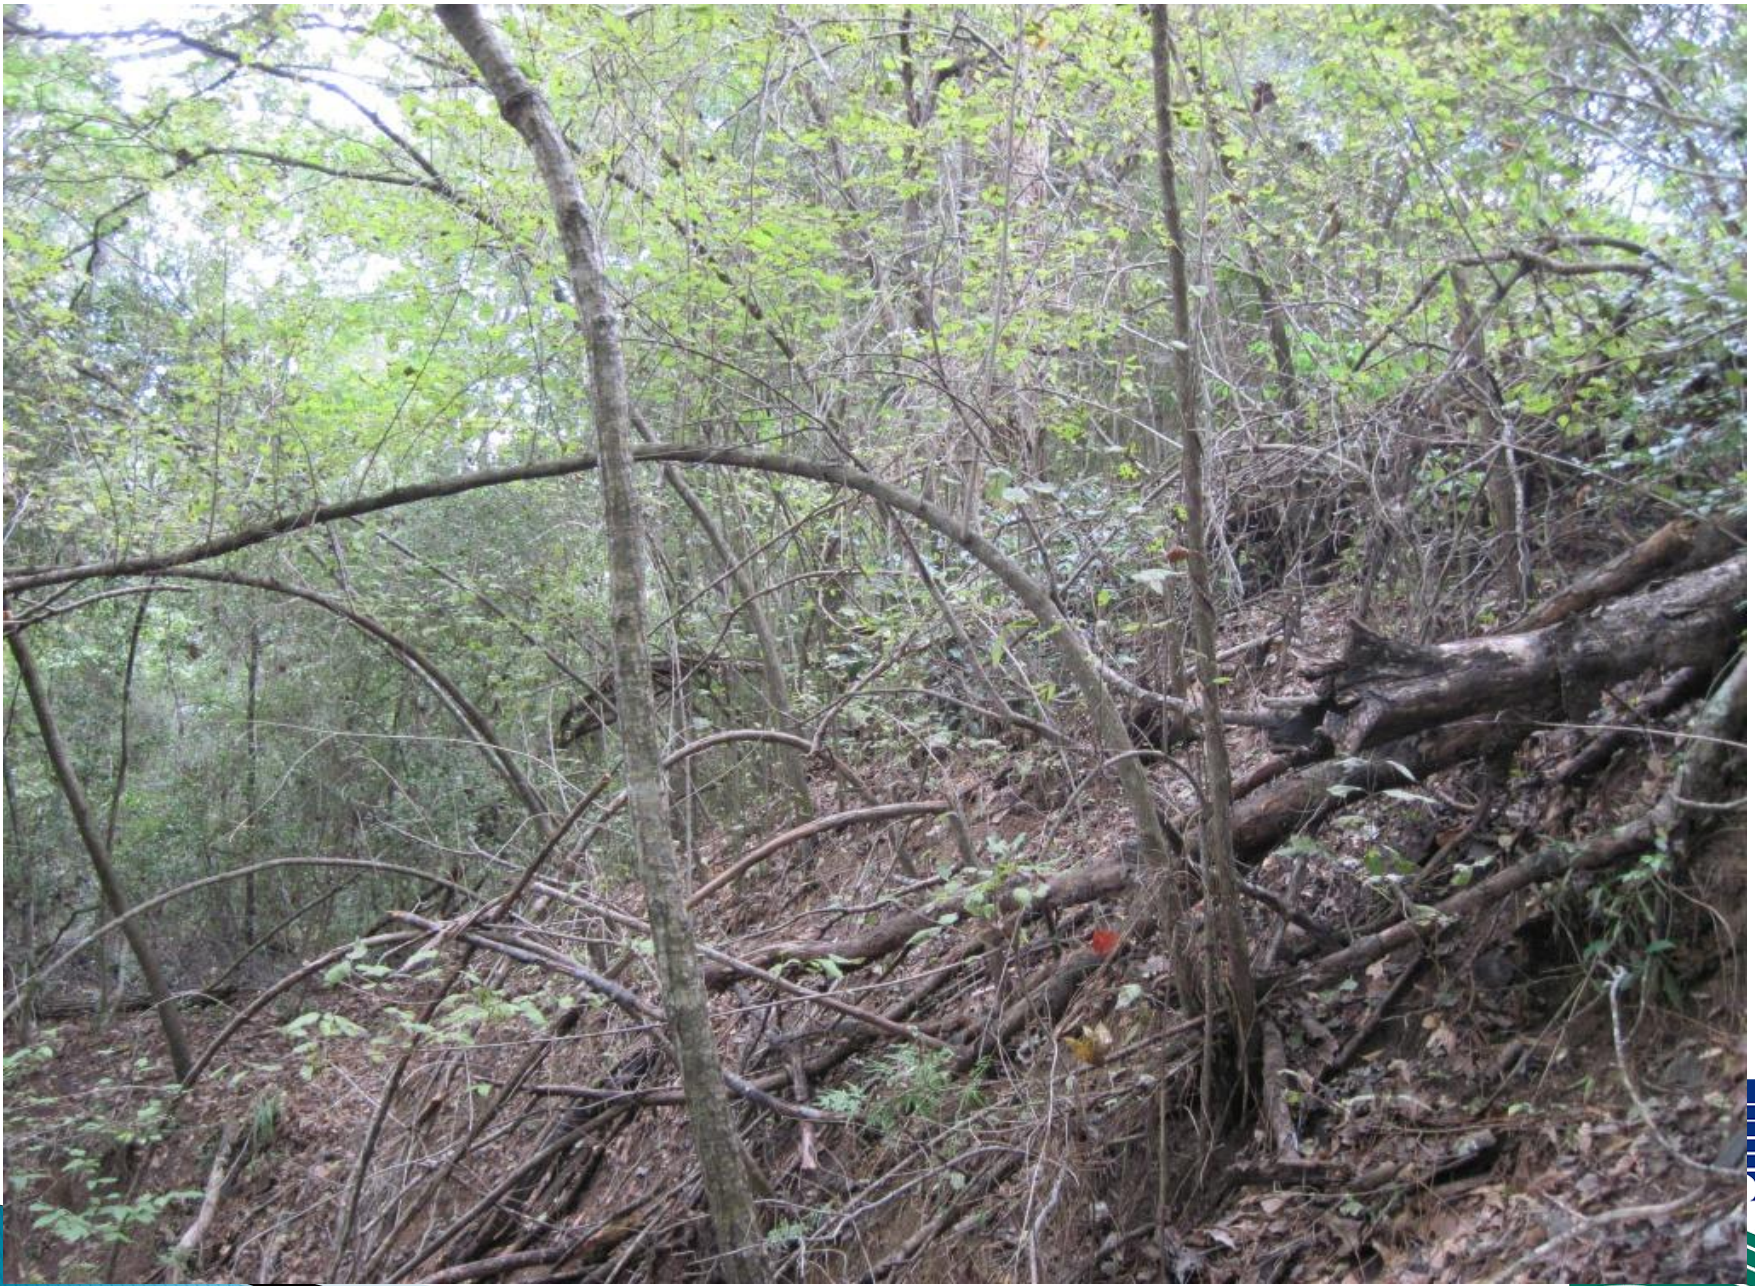
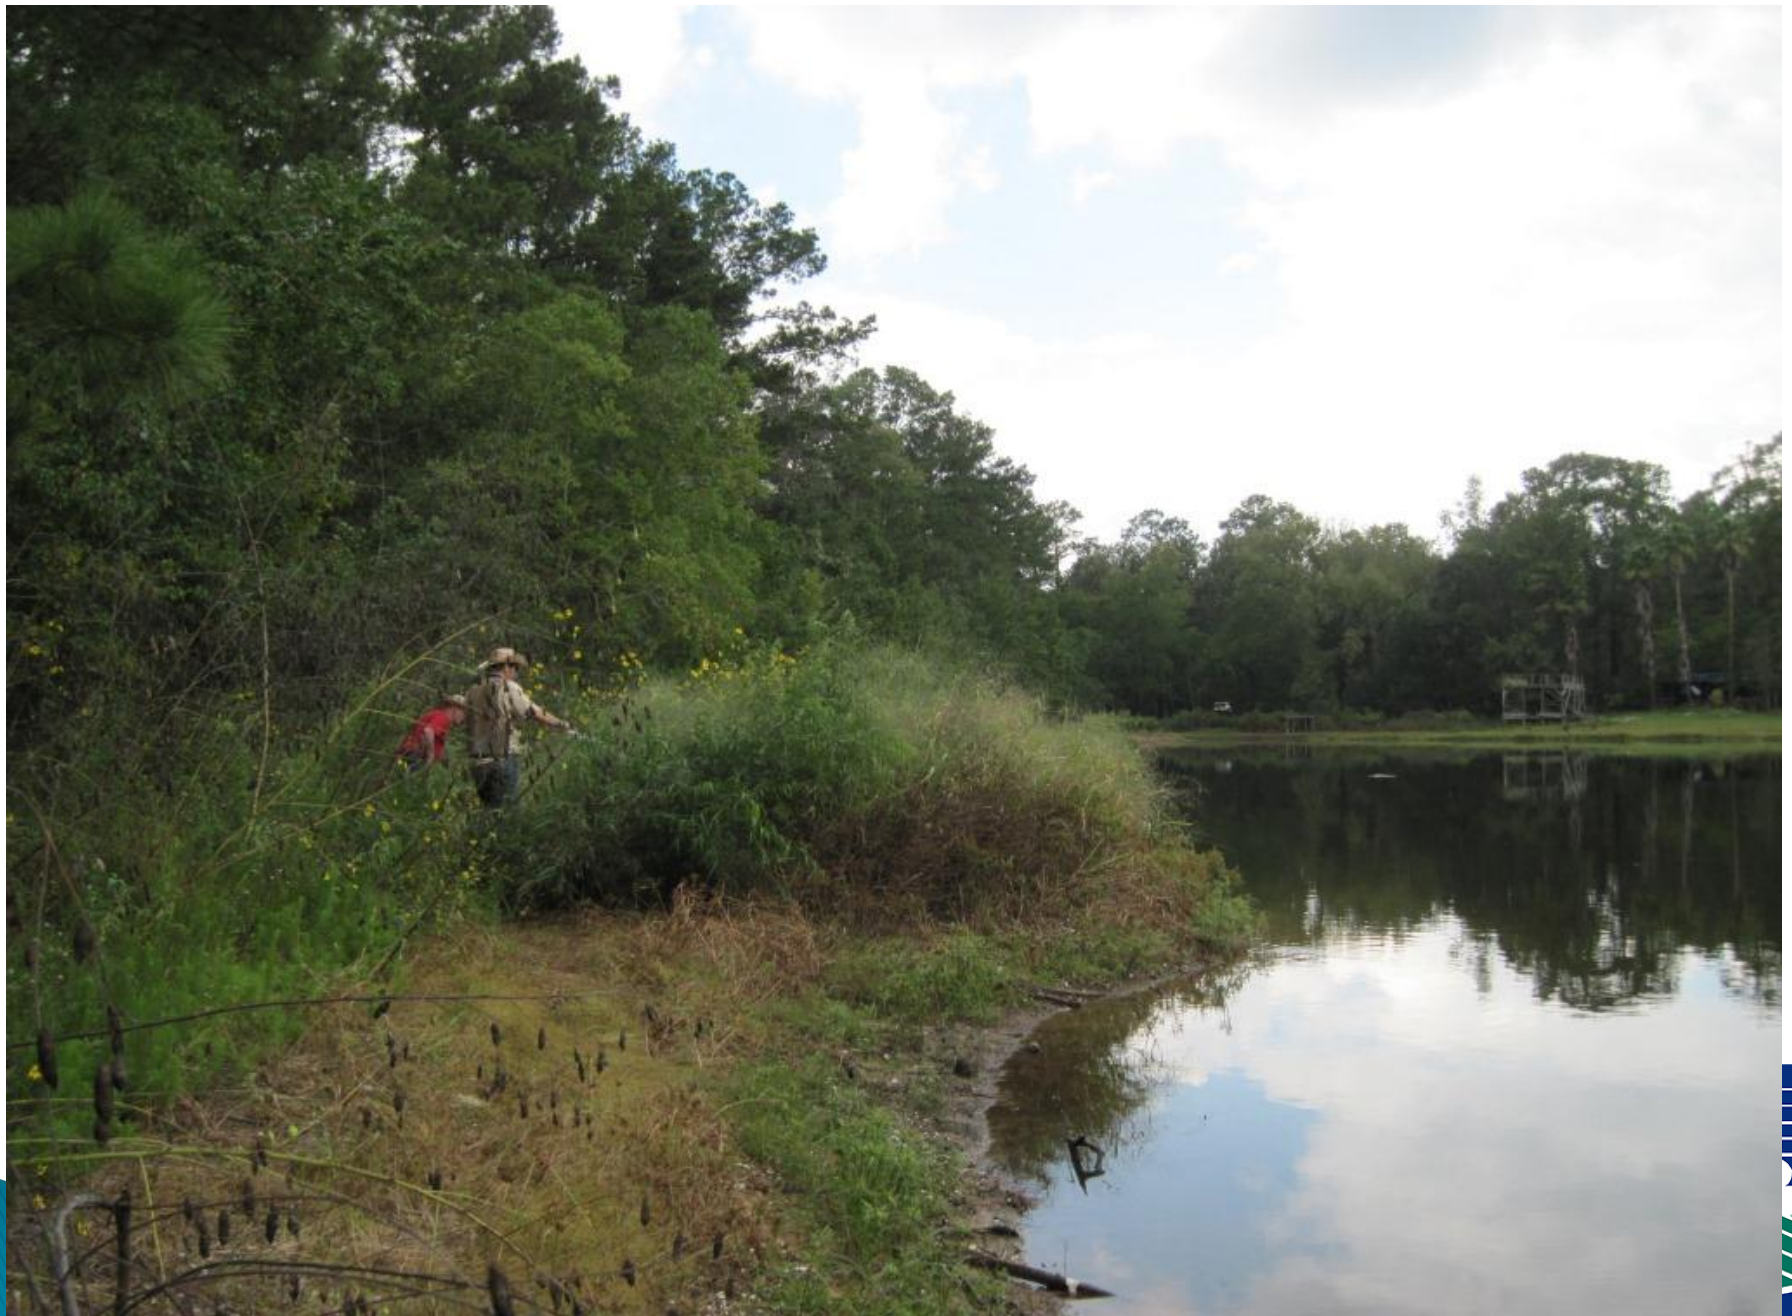
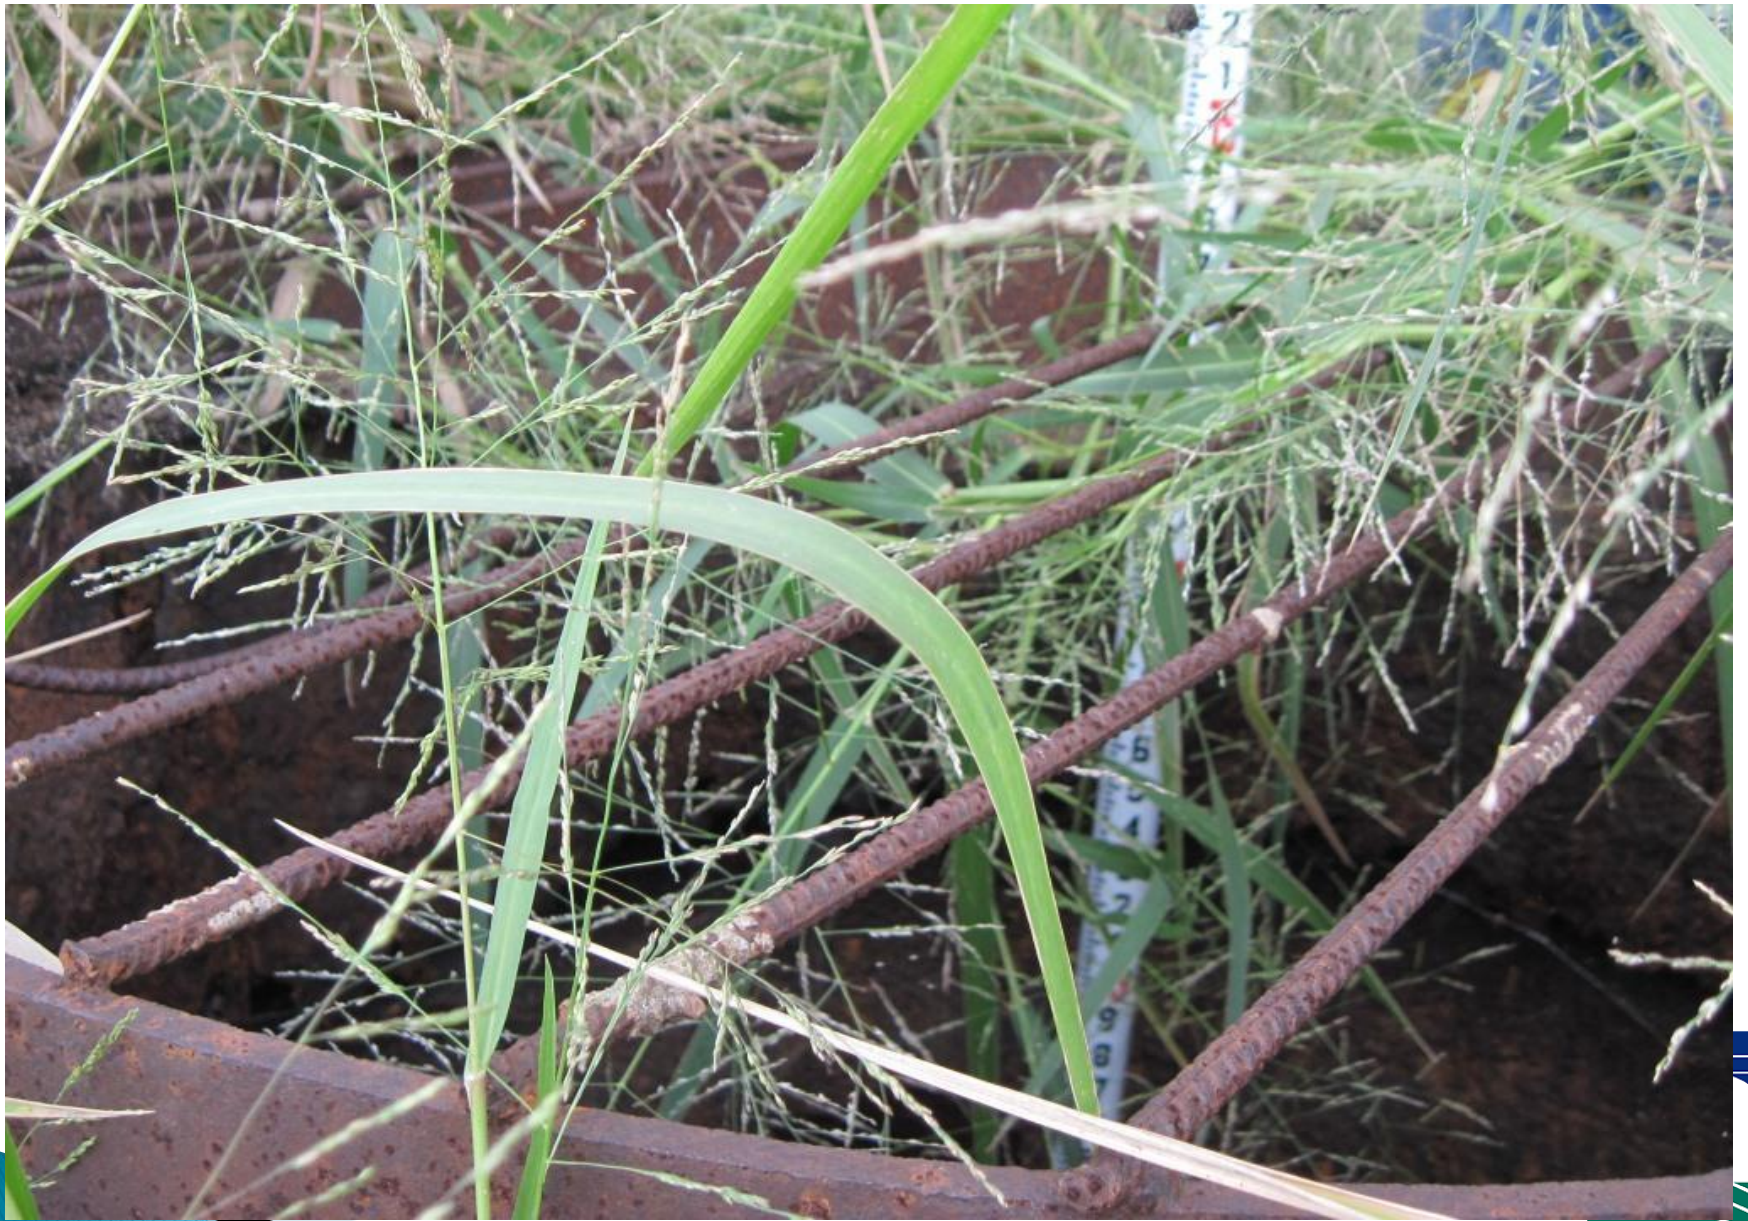
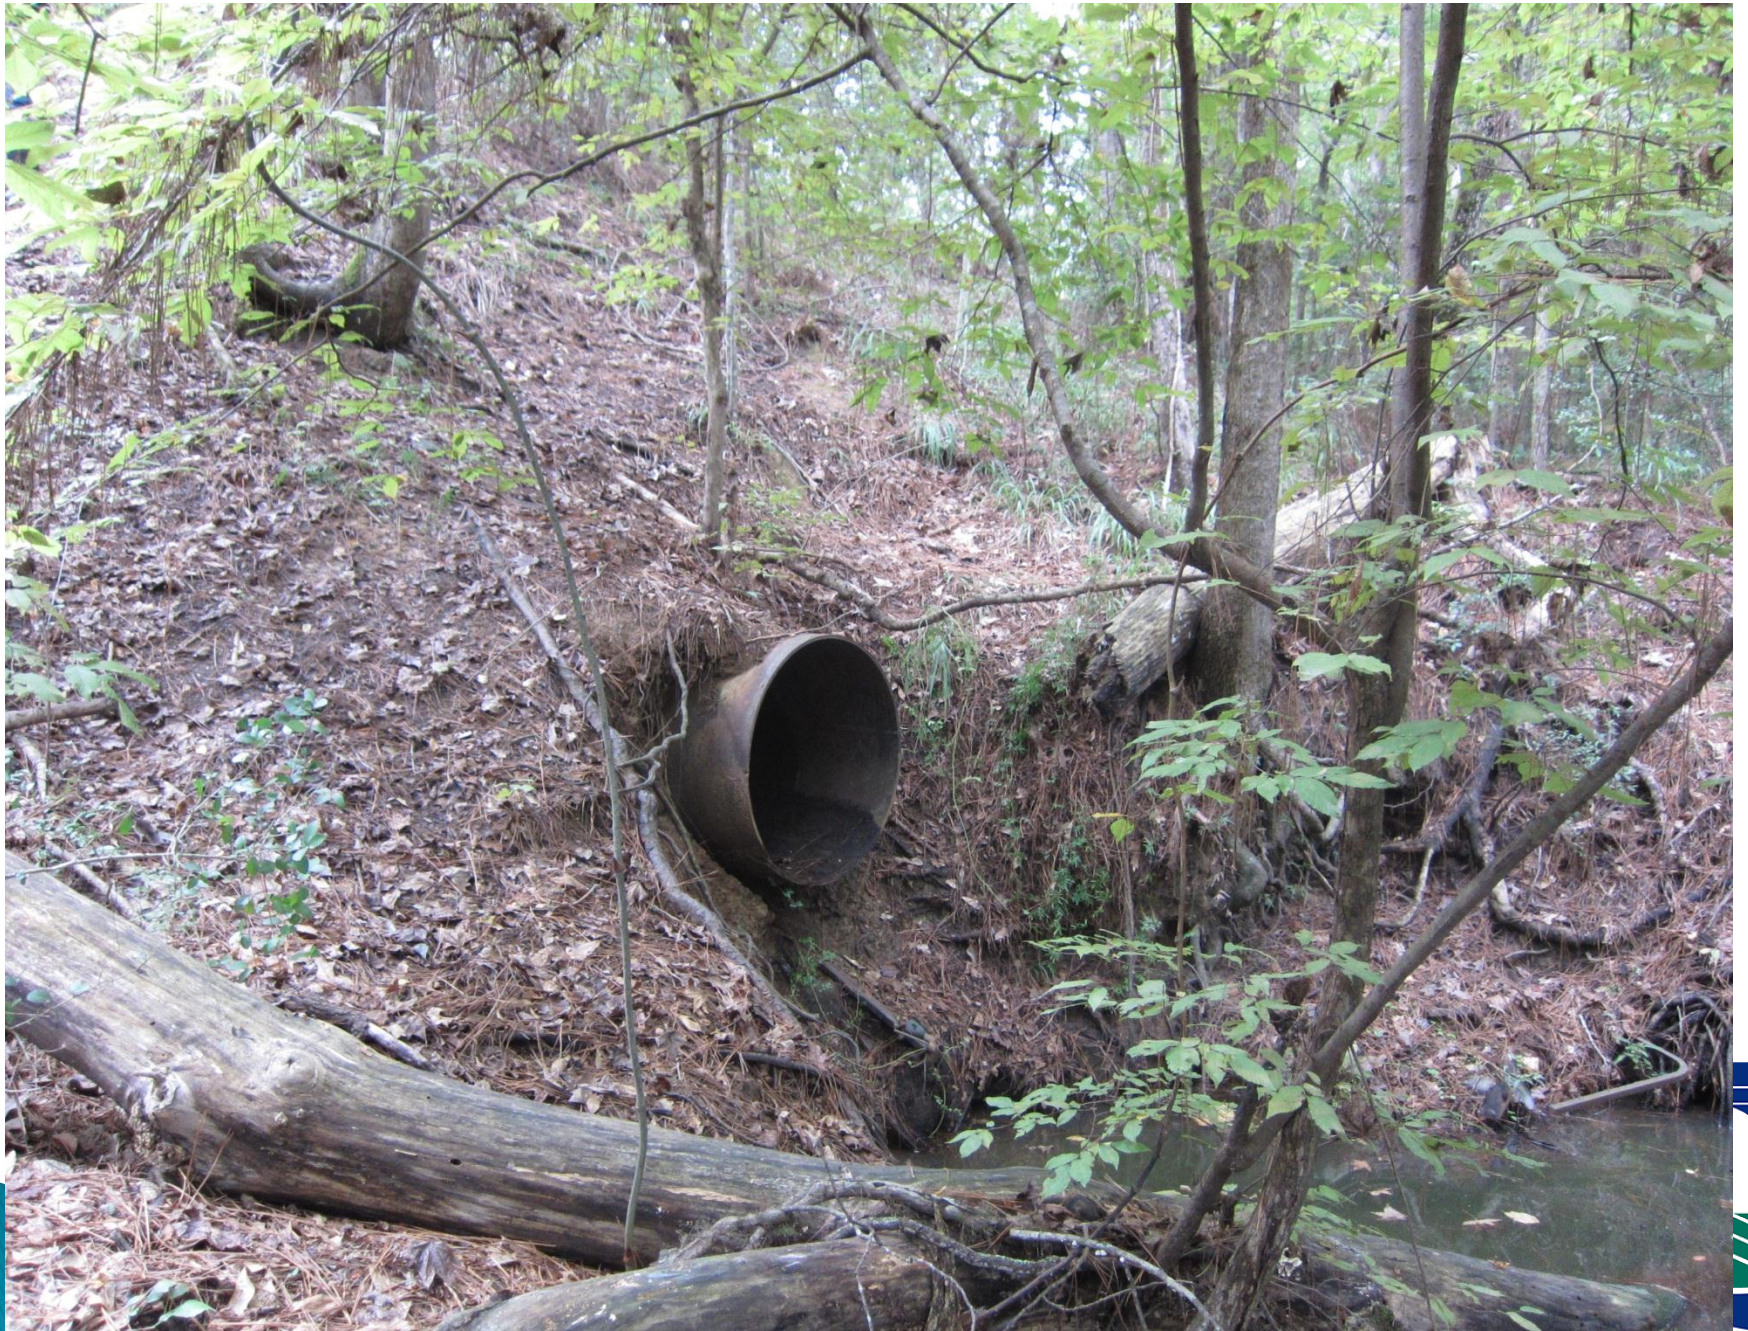
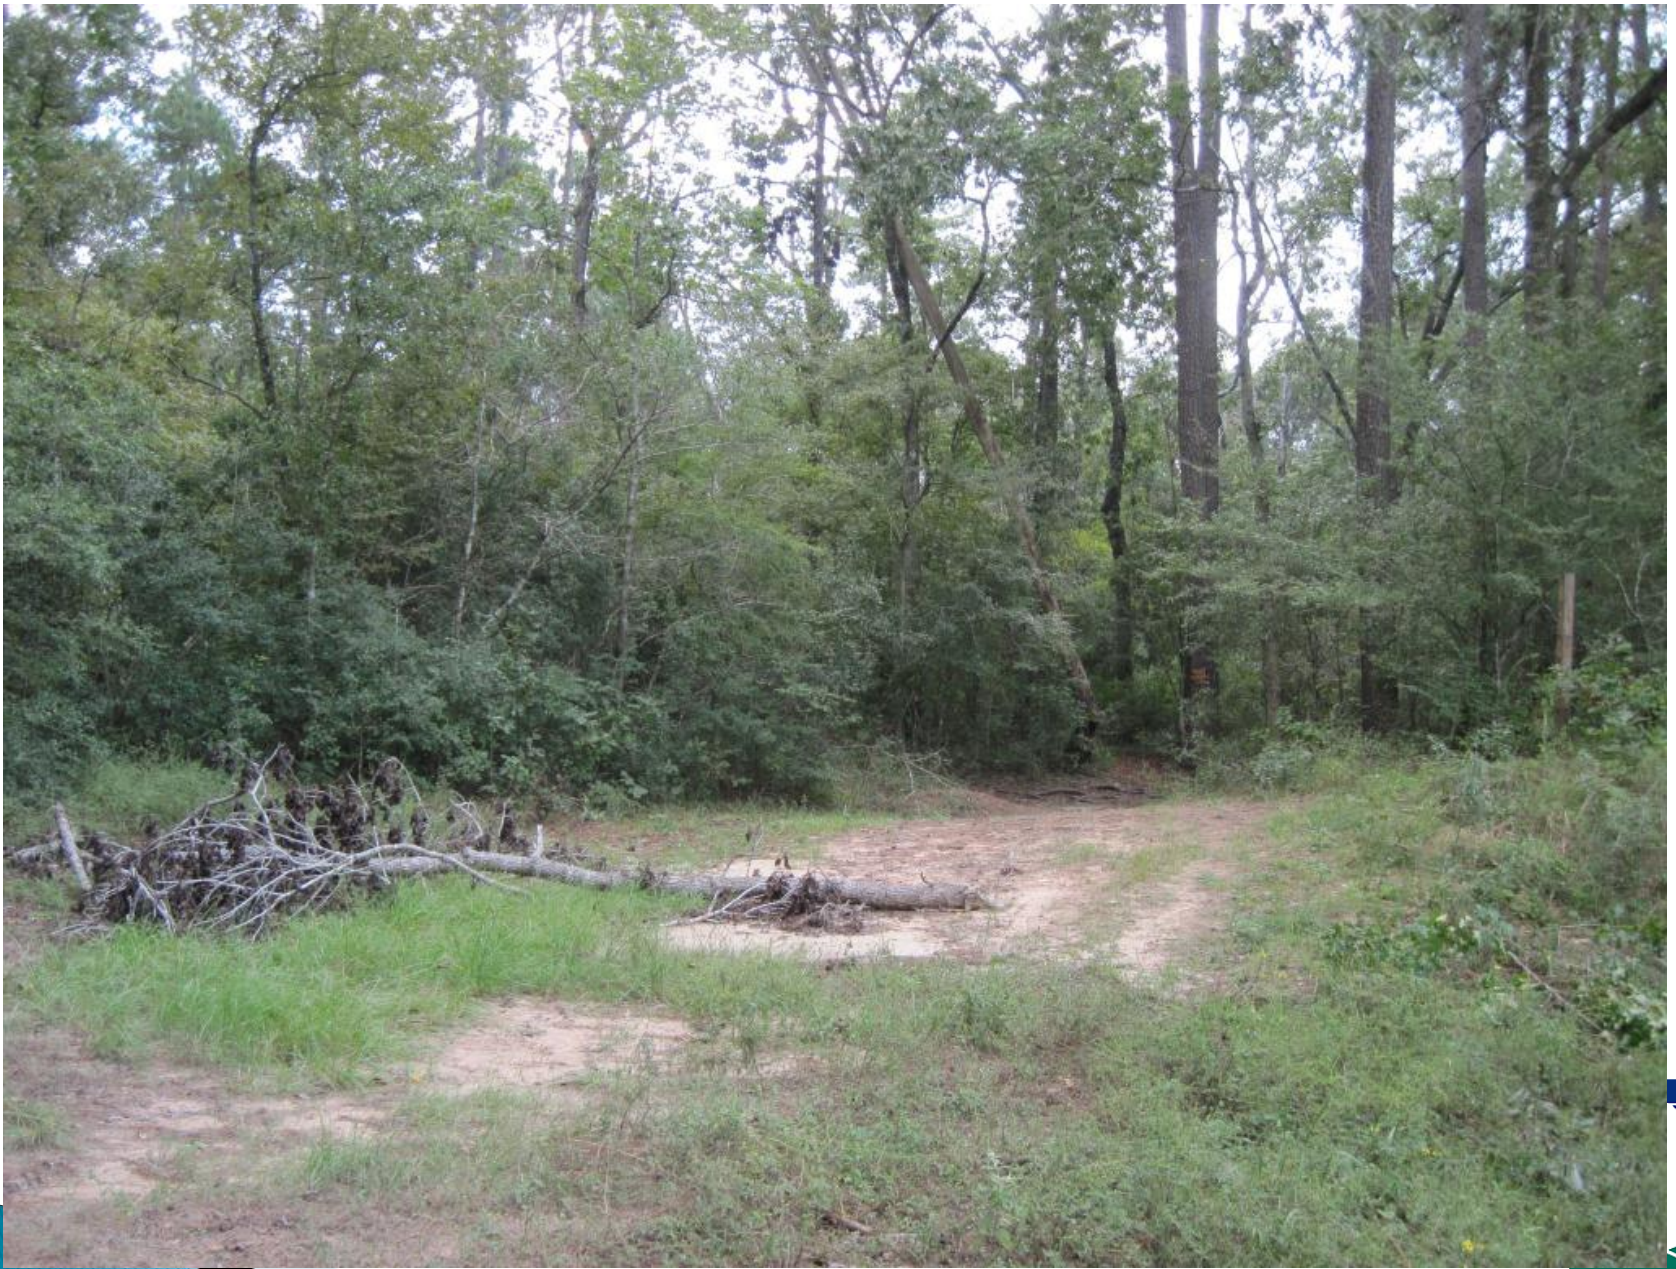
Inspection of another dam

- ▶ Trees, trees, and trees
- ▶ Lack of grass cover
- ▶ Blocked service spillway drop inlet
- ▶ Erosion around the outlet

- ▶ The smaller trees, 4-inches or less, and other vegetation on the dam should be removed. The stumps should be treated with a waterproof sealant to prolong stump decay. A professional engineer should be contacted if the roots are to be removed.
- ▶ A periodic removal or spraying schedule should be established and followed. Tree roots can become pathways for seepage and can alter the structural integrity.
- ▶ Trees can blow over in high winds and severely damage the embankment.

- ▶ After tree removal, establish a good grass cover.
- ▶ Remove all vegetation and debris from around the service spillway drop inlet to allow water to flow through the inlet.
- ▶ The erosion around the service spillway outlet needs to be repaired and protected.

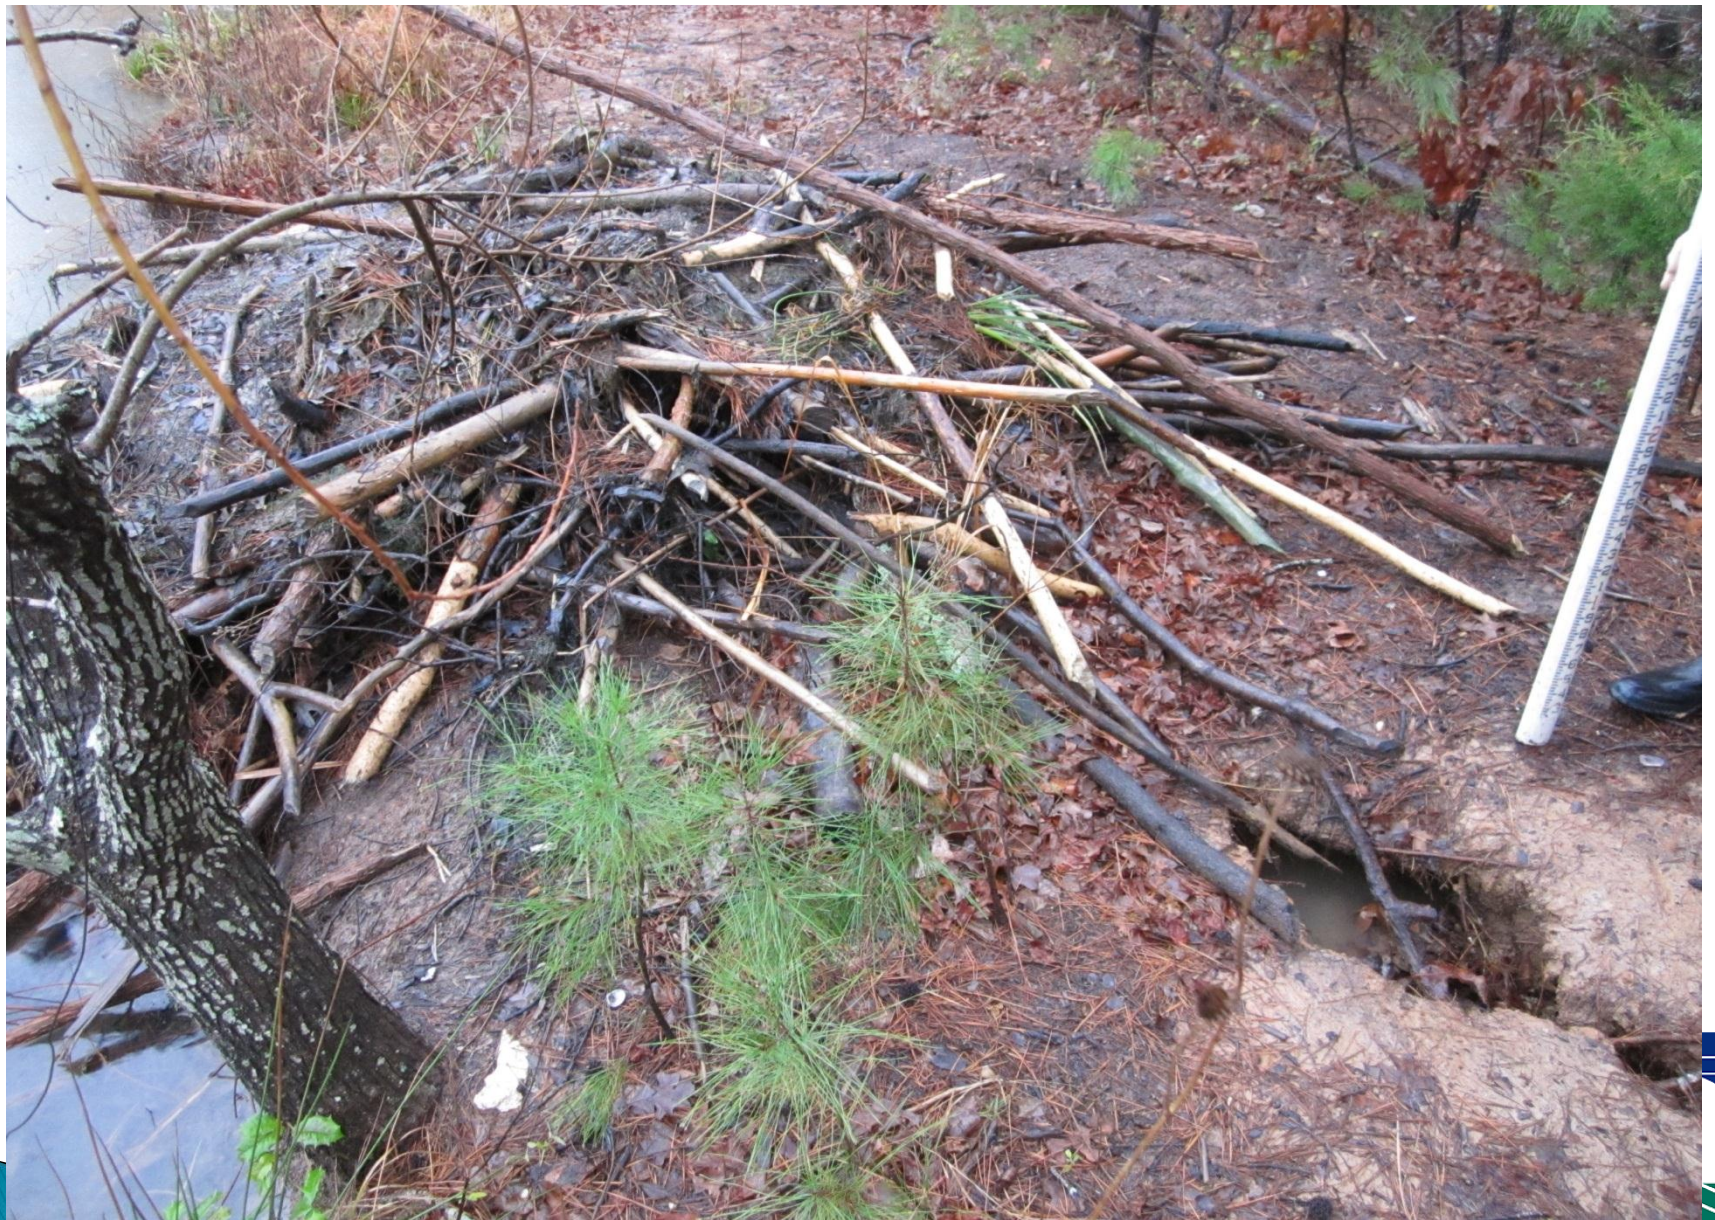
Animals, why be concerned?

- ▶ Burrowing animals can endanger the structural stability of the dam by weakening the embankment and serving as pathways for seepage.
- ▶ Burrowing animals, like beavers, are creating more problems
- ▶ Hogs destroy the protective vegetative cover
- ▶ Livestock trails can promote severe erosion
- ▶ Livestock can overgraze the vegetative cover

- ▶ Take measures to eliminate the animals.
- ▶ For burrows/dens, excavate, backfill, compact, and seed. Also, you can fill hole with grout, cover with soil, and seed or re-vegetate.
- ▶ For livestock trails, fill with soil and compact and then re-vegetate.
